Moraga Country Club HOA

Aquatic Pesticide Application Plan (APAP)

**FOR THE STATEWIDE GENERAL NATIONAL POLLUTANT DISCHARGE ELIMINATION
SYSTEM (NPDES) PERMIT FOR RESIDUAL AQUATIC PESTICIDE DISCHARGES TO WATER
OF THE UNITED STATES FROM ALGAE AND AQUATIC WEED CONTROL APPLICATIONS
TO MEET THE AQUATIC VEGETATION MANAGEMENT REQUIREMENTS
STATEWIDE NPDES PERMIT NO. 2013-0002-DWQ
GENERAL PERMIT NO. CAG990005**

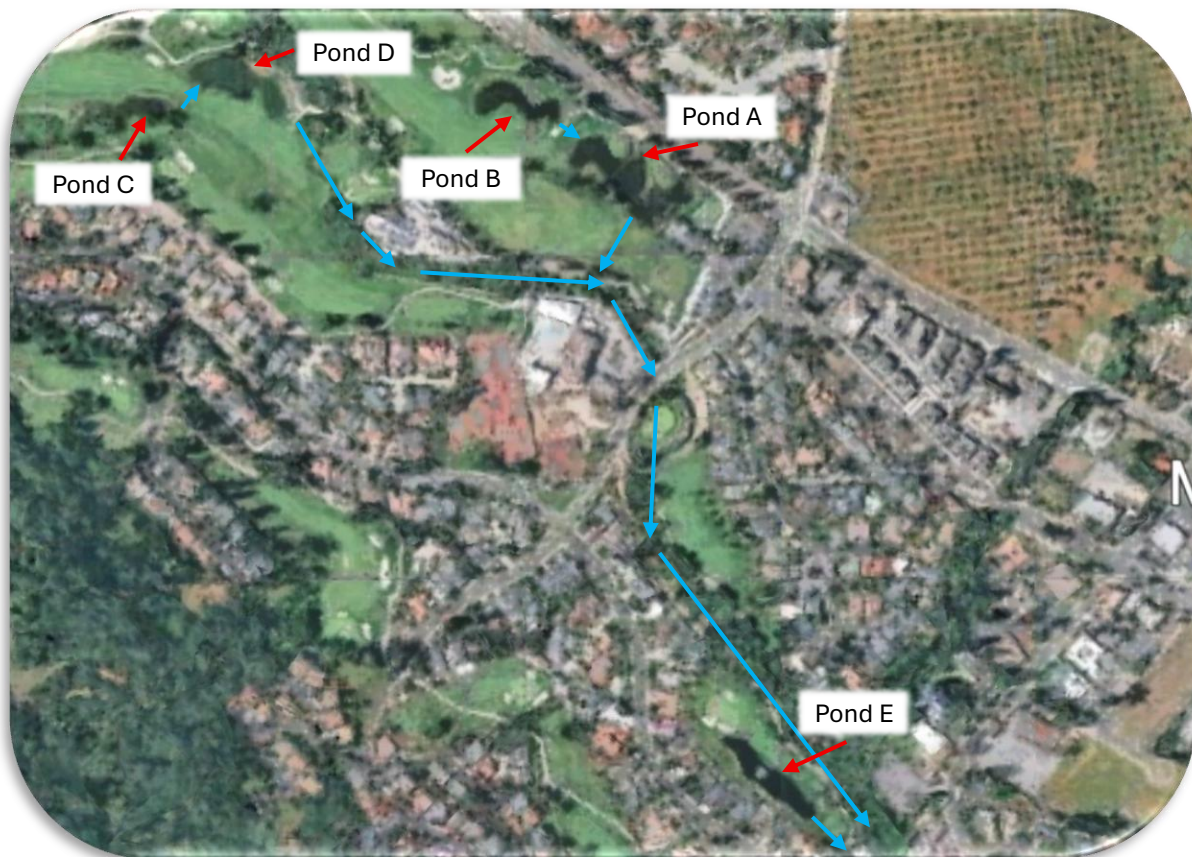
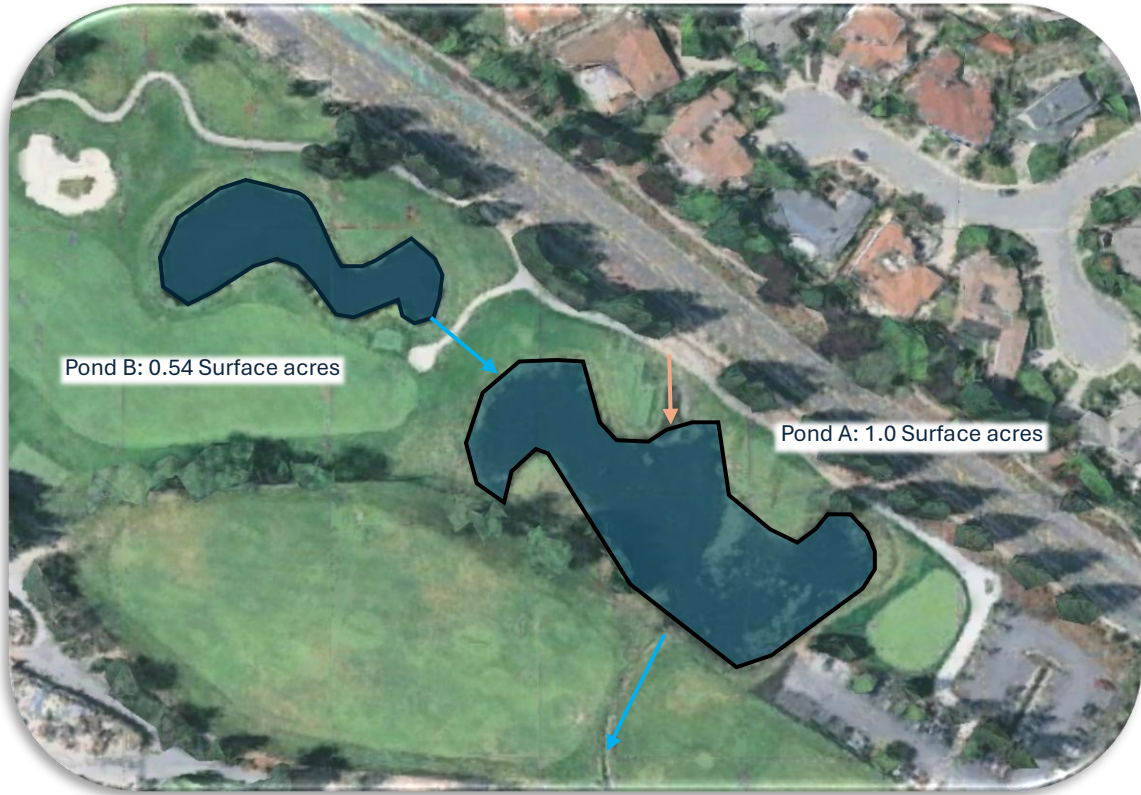
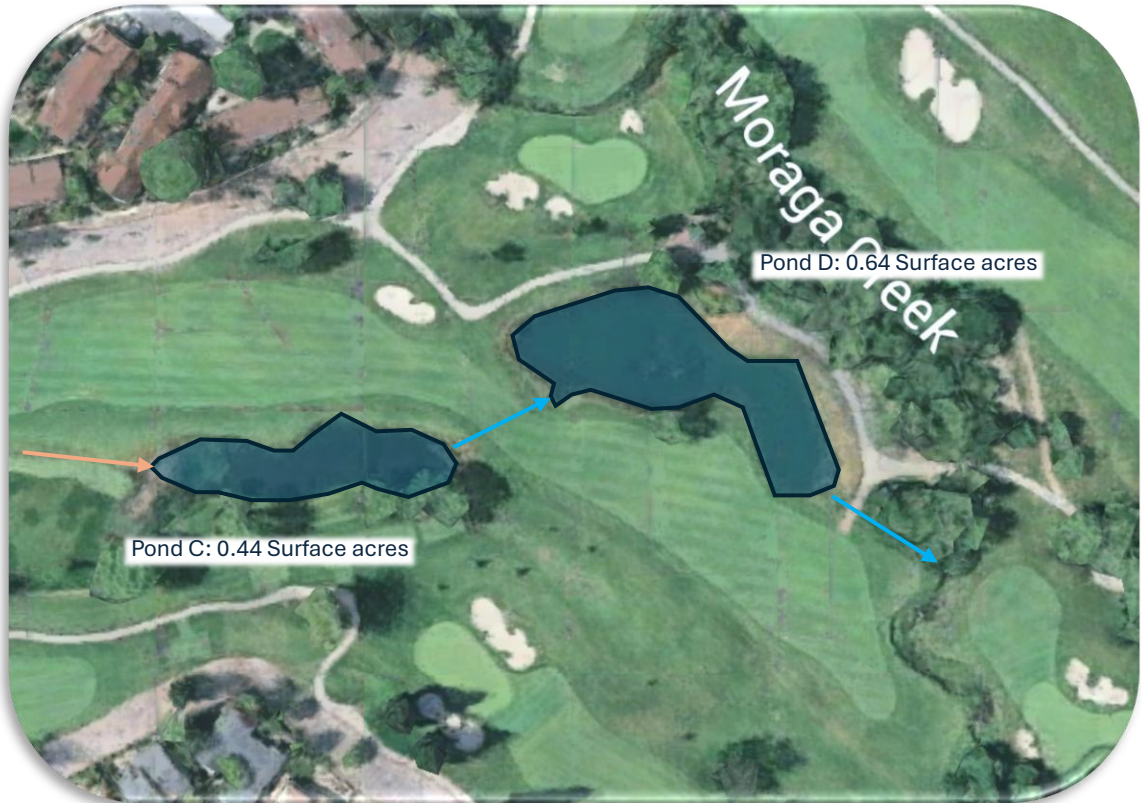
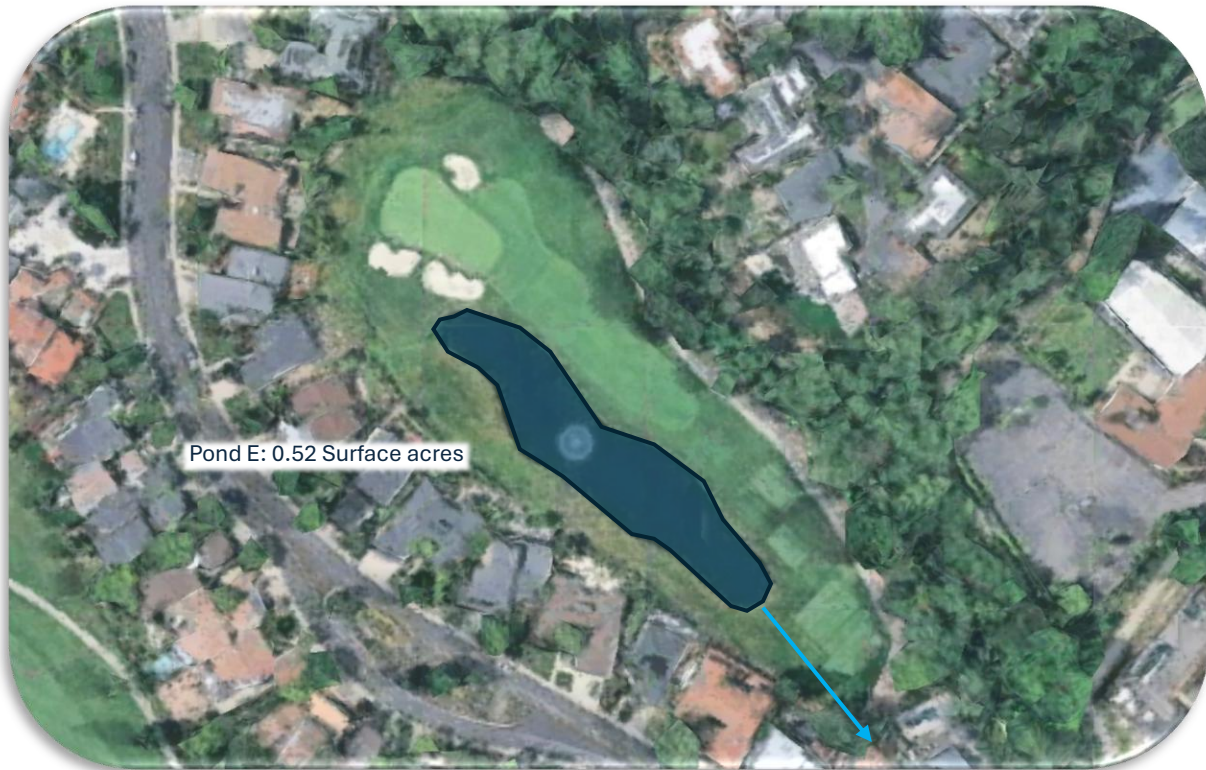
This facility contains a multi-pond water management system consisting of five primary ponds (Ponds A–E) that function collectively for stormwater conveyance, irrigation storage, and controlled discharge to Moraga Creek. The system includes both interconnected surface water features and isolated basins designed to manage inflows from creek sources, stormwater runoff, and internal redistribution for irrigation use.

Pond A and Pond B operate as an interconnected hydrologic unit. Pond A receives direct inflow from Pond B and serves as a secondary collection basin. Additional hydrologic inputs to Pond A include stormwater runoff generated from the surrounding watershed and a small perennial/intermittent creek that flows beneath Moraga Boulevard. This combined system functions as an initial stormwater capture and attenuation area prior to downstream conveyance.

Pond C functions as an upstream irrigation supply reservoir and is fed by a small creek entering the site from the west. Water from Pond C discharges through a manually controlled weir into Pond D. Pond D serves as the primary irrigation storage and pumping basin for the site. A pump system located within Pond D supplies irrigation water to the associated distribution network. Excess water not utilized for irrigation demand is

discharged from Pond D into Moraga Creek through a spillway located on the east end of the lake.

Pond E operates as a independent stormwater retention basin. It does not connect to Ponds A–D under normal operating conditions. When water levels in Pond E exceed design capacity, overflow is discharged via a storm drain system that ultimately conveys flow to Moraga Creek.
